**MILESTONE INSPECTION –
PHASE I REPORT**

MiraVista Condominium – Building B
481 Quail Forest Boulevard
Naples, Collier County, Florida

SOCOTEC Project Number 6521-003.01

April 2023

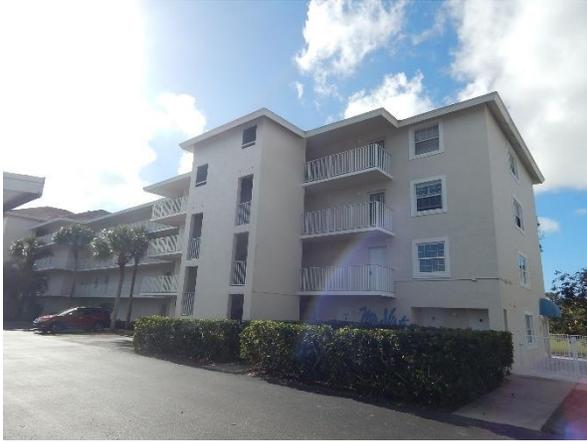
View of front of building.

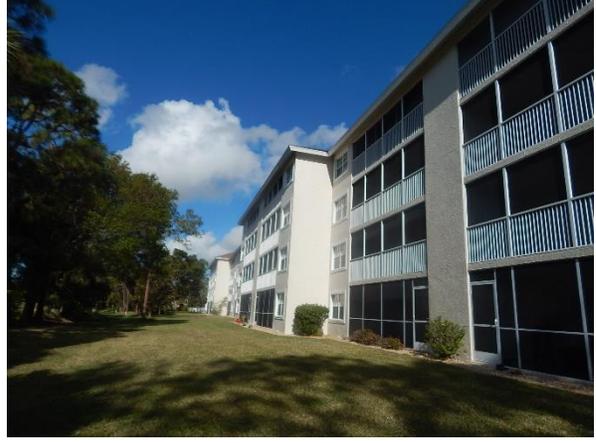
View of rear of building.

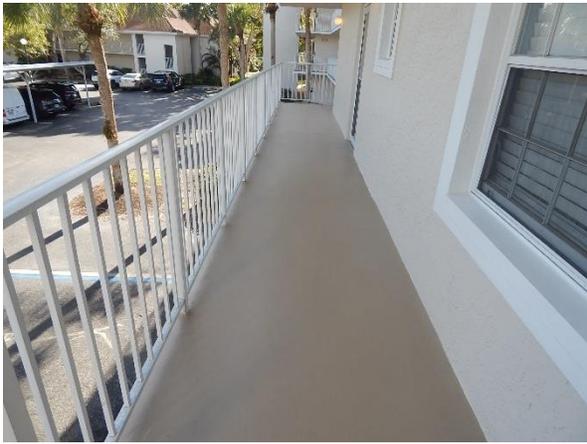
View of breezeway.

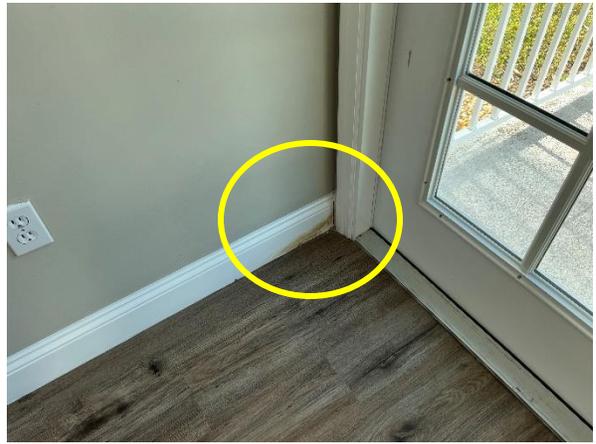
Evidence of water intrusion at social room.

- Evidence of water intrusion in the social room should be further investigated.

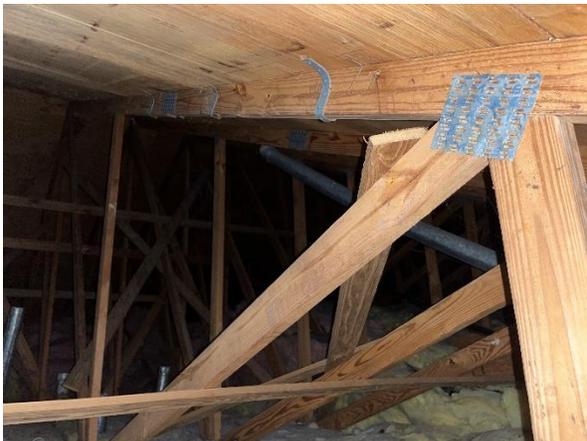
View of roof trusses and decking.

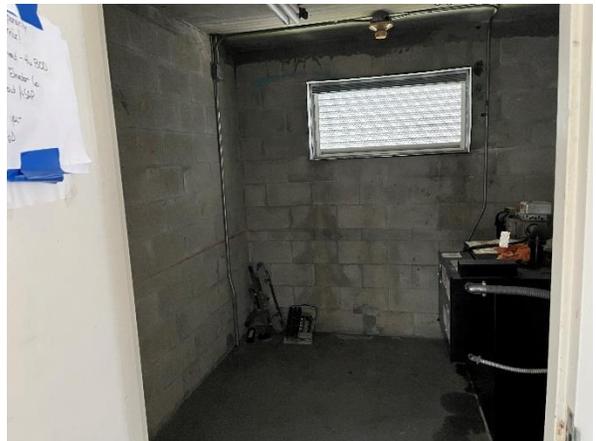
View of elevator equipment room.
