# Uniform Mitigation Verification Inspection Form

| Inspection Date: 06/02/2021 | | |
| Address: 441 Quail Forest Blvd | | Home Phone: |

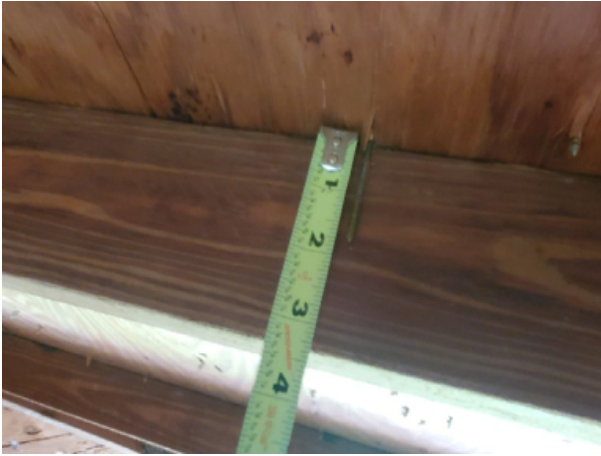
- ☒ C. Plywood/OSB roof sheathing with a minimum thickness of 7/16" inch attached to the roof truss/rafter (spaced a maximum of 24" inches o.c.) by 8d common nails spaced a maximum of 6" inches in the field. -OR- Dimensional lumber/Tongue & Groove decking with a minimum of 2 nails per board (or 1 nail per board if each board is equal to or less than 6 inches in width). -OR-

8d Nail

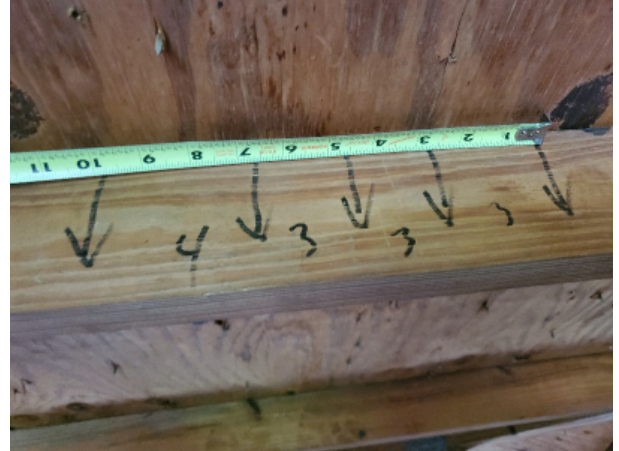
Nail Spacing

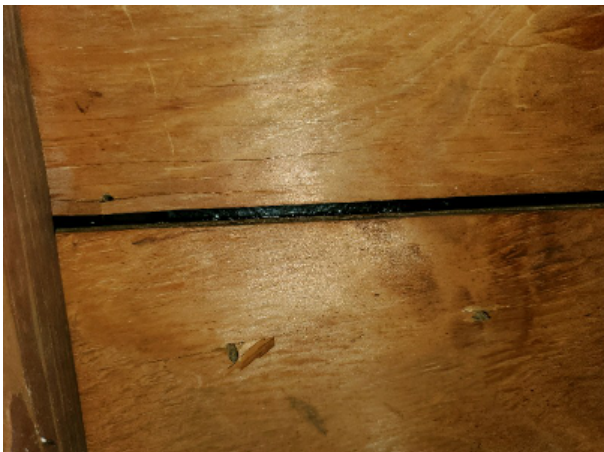
- ☒ A. SWR (also called Sealed Roof Deck) Self-adhering polymer modified-bitumen roofing underlayment applied directly to the sheathing or foam adhesive SWR barrier (not foamed-on insulation) applied as a supplemental means to protect the dwelling from water intrusion in the event of roof covering loss.
- ☐ B. No SWR.
- ☐ C. Unknown or undetermined.

SWR

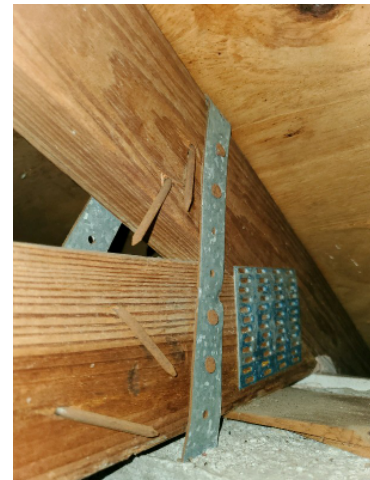
- ☒ C. Single Wraps
  - Metal connectors consisting of a single strap that wraps over the top of the truss/rafter and is secured with a minimum of 2 nails on the front side and a minimum of 1 nail on the opposing side.

Strap - front

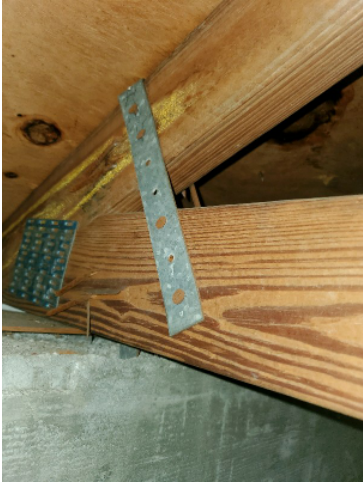
Strap - back
